The Static Testing of a Lockheed P-3
Orion Wing Leading Edge Centre
Section

Albert K. Wong and Glenn Luke

**DSTO-TR-0423**

November 1996

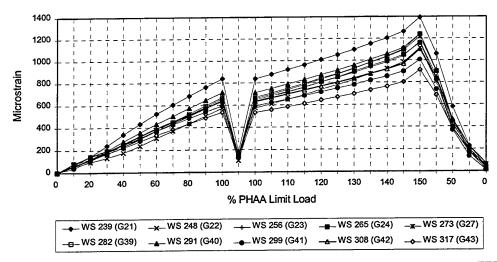
Figure 4. Section EE strains for the PHAA Test.

All internal ribs, from WS239 to WS317, of the test article were strain gauged at the mid-height of the lower web near the hinge line (see Section EE in Figs A8 to A13). The strains recorded for these ribs give an idea about the distribution of load along the span of the test article. Figure 4 shows the entire Section EE strain histories throughout this test. It may be seen that during the first parts of the loading sequence (i-iii of the schedule listed in Section 6.2.1), Section EE strains responded relatively linearly with respect to the applied load. The exceptions for this occurred at WS239 and WS248, where the non-linearities shown were most probably due to geometric effects (e.g., these webs might have been initially bowed) as they occurred at relatively low strains (approx. 20% of DLL) and disappeared in the later parts of their excursions.

For the second part of the loading schedule (iv and v of Section 6.2.1), all Section EE strains began to depart from linearity at approximately 130%DLL. Because strains experienced were relatively low (below 1400 microstrains), the non-linearities seen here were not attributable to local yielding at these locations.

Figure 4 also shows a table of Section EE strains at various critical stages during the test, viz., at a) load-up to 20%DLL; b) 100%DLL; c) load-down to 20%DLL; d) load-up

to 150%DLL; and e) complete load removal. It may be noted that the residual strains at this location after unloading from both DLL and DUL (c and e) were only of the order of 5%, and may be considered acceptably small for such a fabricated structure.

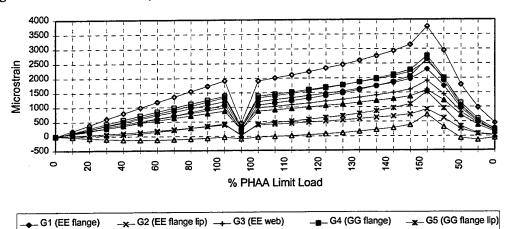
Figure 5. WS228 Lower leg strains for the PHAA Test.

As shown in Figs A8 to A10, 3 selected ribs (WS228, WS273 and WS317) were equipped with extra strain gauges to provide more detailed strain data. The lower leg strains for these ribs are shown in Figs 5-8. As expected, the lower leg strains under the applied load were predominantly in tension and progressively increased from Section EE through to Section FF as the sections approach the tangency point (near Section KK, see Fig. A9 for example). The recorded strains across these sections (EE, GG, FF) were all below 4000 microstrains, although they generally began to respond non-linearly with respect to the applied load at around the 120%DLL mark. For WS228, it is interesting to note that the strain at the vertical lip of the flange at Section FF (Gauge-9 in Fig. 5) initially became negative. This was due to the section being near the tangency point where there could be a large variation across the flange as a result of the curvature of the flanged (see [3,5]).

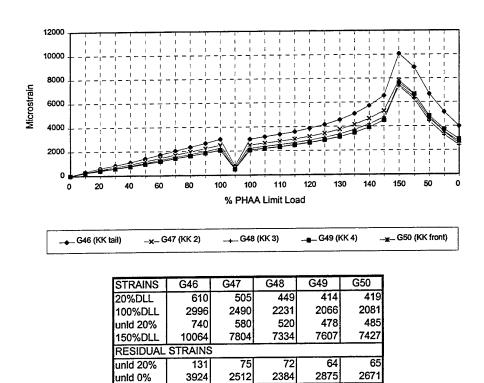
Beyond 120%DLL, the Section KK strains at WS273 rapidly increased such that the yield strain of approx. 5,000 microstrains was reached at 135%DLL and proceeded exponentially to approx. 10,000 at DUL. It may also be noted from the table shown in Figs 7 that whilst the residual strain introduced by the DLL loading were insignificant, they were extremely high (approx. 3900 microstrains) as a result of the DUL loads.

Figure 7. WS273 lower leg strains at critical region for PHAA Test.

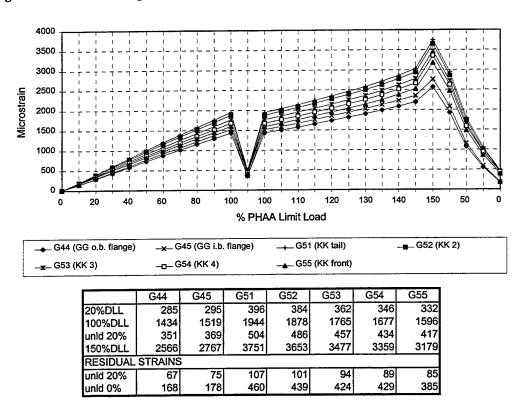
Figure 8. WS317 lower leg strains for the PHAA Test.

The ribs at WS273 and WS317 were also equipped with a 5x1mm strip gauge at the expected critical location (Section KK), and their recorded strains are shown in Figs 7 and 8. As expected the strains here were much higher than those at the other sections (EE, GG, FF). It is interesting to note that, at DUL, the highest recorded strains reached at WS273 (midspan rib) were approx. 10,000 microstrains compared to approx. 3,750 microstrains reached at WS317 (furthermost outboard internal rib). The lower strains exhibited by this outboard rib were due mainly to the fact that the rib spacing between this rib and the adjacent outboard closure rib is approximately half of the normal spacing. This evidence does not support the earlier conclusion that the WS317 rib might have been the critical rib (see Callinan *et al* [2]).

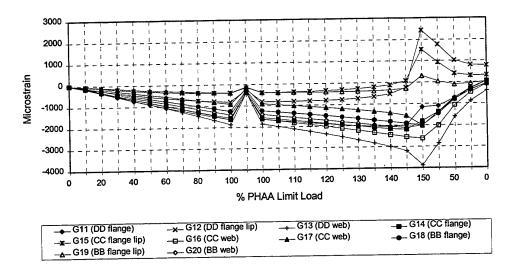
Figure 9. WS228 upper leg strains for the PHAA Test

The upper leg strains for the WS228 and WS273 ribs are shown in Figs 9 and 10. In contrast to the lower leg, this part of the structure supported the compressive loads under the applied lifting forces. Consequently, the recorded strains here (Sections BB, CC, DD) were generally comparable in magnitude, but opposite in sign, to those of their tensile counterparts (Sections EE, GG, FF). Under compression, however, the vertical part of the flange lip would have an increased tendency to buckle, and thus lost most of its effectiveness beyond 100%DLL (compare Gauges 12, 15 and 19, Fig 9 with Gauges 9, 5 and 2, Fig 5 respectively). The low levels of residual strains upon unloading tend to suggest that such behaviour was due to elastic buckling.

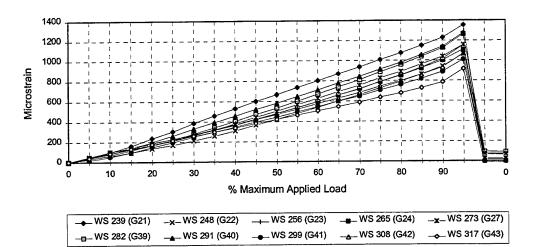
Figure 13. Section EE strains for the PLAA Test: a) 4g case, b) 4.5g case.

Section EE strains along the span are shown in Fig. 13. The test article survived 100% of the 4g load case and the maximum Section EE strain attained was for WS239 reaching approx. 1,080 microstrains. The strains behaved relatively linearly throughout this test and were lower than those for the PHAA case at DUL. For the 4.5g load case, the strains also behaved surprisingly linearly and the maximum recorded strain at this Section was approx. 1,350 microstrains at 95% of the 4.5g load at WS239. The test article failed during the load excursion between 95% and 100% load. From the audio tracks on the video recordings, it was deduced that catastrophic failure occurred virtually immediately after the load was being increased from 95% level. The mode of failure is discussed later in Section 6.4.2.

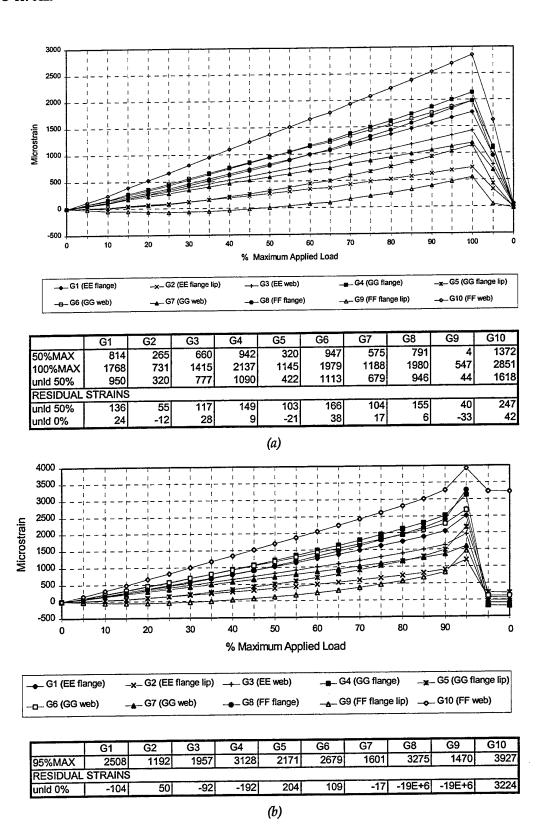
Figure 14. WS228 lower leg strains for the PLAA Test: a) 4g case, b) 4.5g case.

The lower leg strains of ribs WS228, WS273 and WS317 for the PLAA Test are shown in Figs 14 to 17. As was seen in the previous Section, the tensile strains for the PLAA 4g case were less severe than those seen at DUL under the PHAA condition, but the maximum strains reached at 95% of the 4.5g case were slightly higher. The maximum recorded strains at the critical region (Section KK) for WS273 was 11,571 microstrains just prior to failure.

Interestingly, the PLAA strains appeared to be more linear compared to the PHAA case with respect to the applied load. This is most probably due to the fact that the PLAA Test was conducted after the PHAA Test during which some degree of strain hardening would have taken place (as mentioned in Section 6.2.2b, yielding at the critical region would have occurred at around 135%DLL during the PHAA Test).

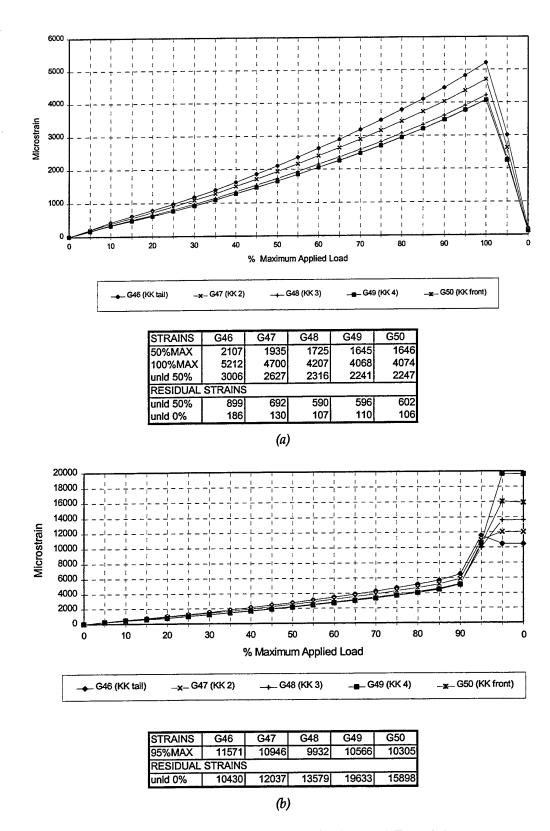
Figure 16. WS273 lower leg strains at critical region for the PLAA Test: a) 4g case, b) 4.5g case.

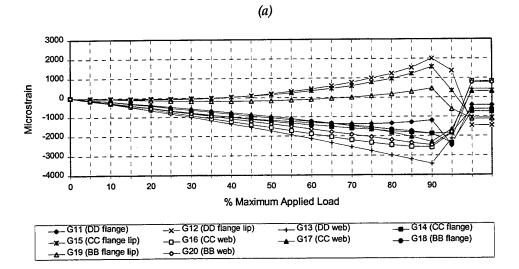
Figure 18. WS228 upper leg strains for the PLAA Test: a) 4g case, b) 4.5g case.

The PLAA upper leg strains for the ribs at WS228 and WS273 are shown in Figs 18 and 19. As mentioned earlier, the upper leg sustained the compressive loads under the applied lifting forces. The strains here behaved much the same as the PHAA Test although it may be seen that the vertical part of the flange lip for the PLAA Test now became even less effective than for the PHAA Test. This, again, may be attributed to the prior permanent deformation which was introduced during the PHAA Test. The evidence of this is much clearer here as, for example, it may be seen from Fig. 9 that Gauges 12 and 15 on WS228 showed noticeable tensile residual strains at the completion of the PHAA Test.

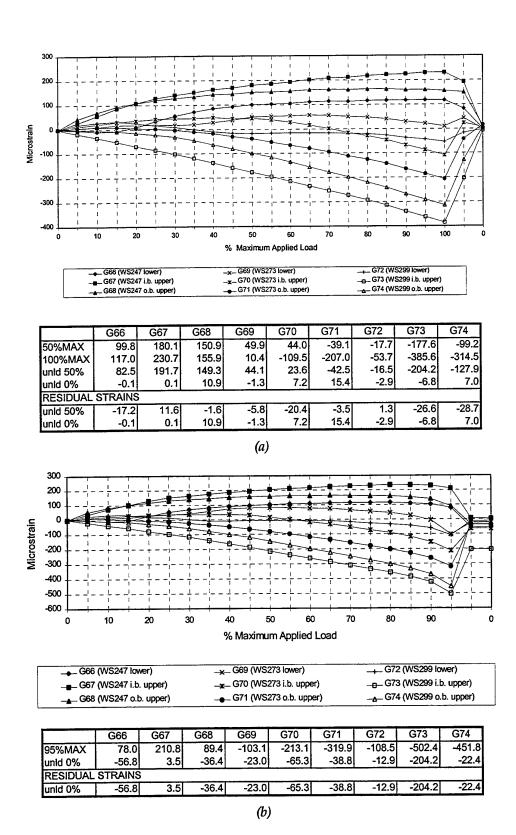
Figure 20. Skin strains for the PLAA Test: a) 4g case, b) 4.5g case.

Figure 20 shows the skin strain readings throughout the PLAA Test. The skin gauges showed that similarly low strains were reached compared to those of the PHAA Test. However, the PLAA results showed a noticeably more linear response with respect to the applied load. One exception seen was with Gauge 72 (on the lower skin near WS299) in which little strain was experienced throughout the PLAA Test whereas this gauge recorded the highest skin strains during the PHAA Test. Partial detachment of this gauge is one possible explanation, although this was not likely as the strains reached during the PHAA Test was low (approx. -520 microstrains). A more likely explanation may be the fact that the rear row of lower pads were moved rearwards closer to the skin gauges for the PLAA Test and therefore affected the local skin strains.

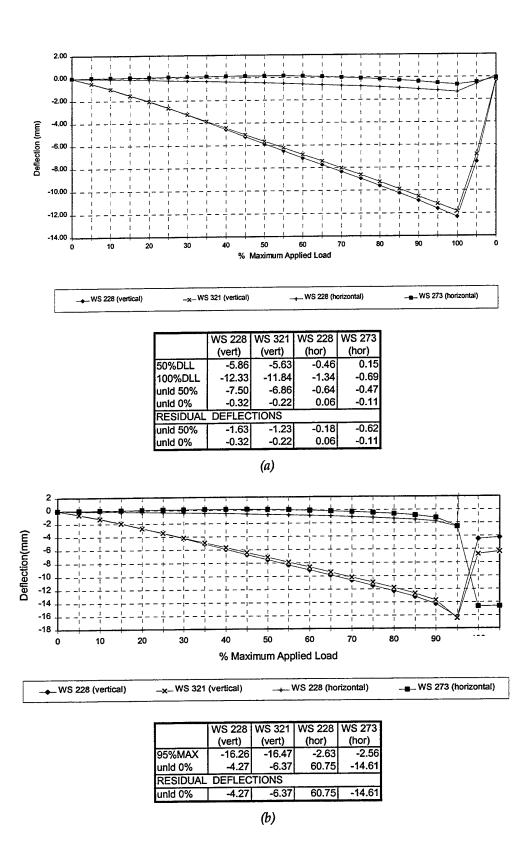
Figure 21. Deflections for the PLAA Test: a) 4g case, b) 4.5g case.

The deflection measurements for both cases of the PLAA Test are shown in Figs 21. It may be seen that the test article deflected relatively linearly and with little difference between the inboard and outboard ribs throughout the Test. Rapid loss of overall stiffness was evident between 140%DLL to 150%DLL. In particular, the rapid relative increase in lateral deflection in the final stages highlights the buckling of the upper leg at high loads. However, it is to be noted that over the 85%-90% of the 4.5g load range, the deflections for WS273 did not show a disproportionate increase, whereas the strains at the critical region (Section KK) have already begun to increase markedly. This strongly suggests that failure was not preceded by a sudden loss of compressive stiffness of the upper leg, but rather, that the ultimate strain at the critical region was duly reached.

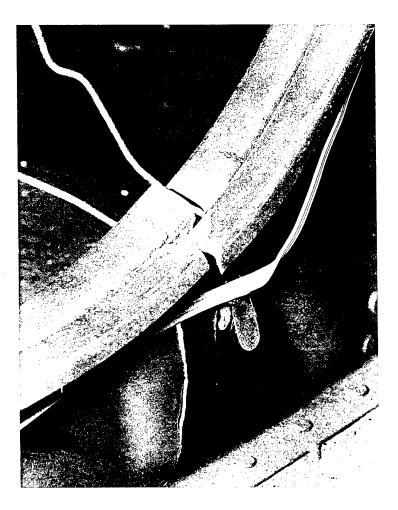
During the load increment between 95% and 100% of the 4.5g load case, a loud "bang" emanated from the test article signifying the failure of the test article. As mentioned earlier, the video records revealed that the breaking point occurred soon after the 95% level. With the loss of stiffness, the controller shut down the hydraulic system and the test load was effectively removed. Whilst the test article was still mounted in the test rig, an initial inspection of the failure sites were performed and photographs of the deformed ribs were taken. It was found that each of the 13 ribs was fractured at the tangency point on the lower leg (see Fig. 22 for example). For the internal ribs, the line of failure traversed across the lowermost stiffening dimple as found in the accident case. It was not possible to determined from the inspection which of the ribs had failed first, although from the strain data, it would appear that the WS239 was the most likely candidate as it had experienced the highest strains throughout the tests.

Figure 22. Typical fracture on the lower leg of the rib.

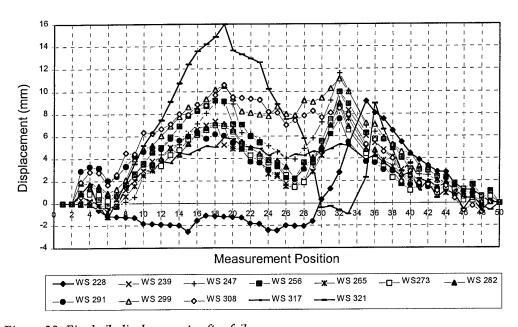
From the strain data, it was seen that at least some parts of the test article had undergone plastic deformation prior to failure. This was also reflected most clearly by the permanent deformation of the ribs at the conclusion of the tests. To quantify this, detailed measurement of the deformed shapes of each rib was carried out. This was achieved by dividing the inner perimeter of each rib into 50 evenly spaced locations and a distance was measured from the centre-line of each rib at these locations to a reference plane mounted on the inboard closure rib WS228. Because the inboard rib is canted, there was a linear component of the measurement associated with this inclination which could be effectively removed. Figure 23 shows the results of the measurements after the canted components were removed. Some of the noteworthy locations are as follows:

Figure 23. Final rib displacements after failure.

It may be seen from the results that most of the ribs deformed similarly, and predominantly in the positive (outboard) direction. There were 2 dominant peaks, namely, one near Position 19 corresponding to the critical location, and one near Position 32 which was the counterpart of the citical location on the upper leg. Some departure from this general trend was seen for the 2 closure ribs (WS228 and WS321), both of which were structured significantly differently from the internal ribs. For the

An interesting feature to note is the sharpness of the deformation peaks on the compressive legs for all ribs, which reflect the sharp folds formed by the compressive collapse of this part of the structure when failure occurred.

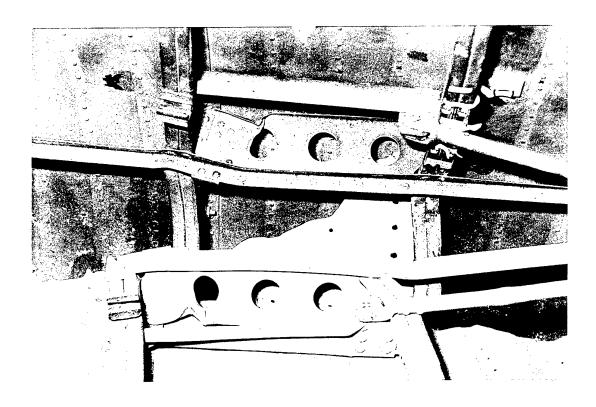
Some parts of the failed structure from the test also showed remarkable resemblance to the recovered crashed article from the RAAF Orion A9-754. For example, Fig. 24 shows the collapsed intercostal near the midspan for both the test and crashed articles where the good likeness in the collapse of these components can be clearly seen.

Figure 24. Comparison of the failed parts near the midspan inter-costal between the test article and that from RAAF A9-754 (the lower component is from the A9-754 starboard centre WLE and thus the mirrored image compared to the portside test article).
